Location # 25
Texas Ave SE, E St SE, & Chaplin St SE

TEXAS AVE CORRIDOR

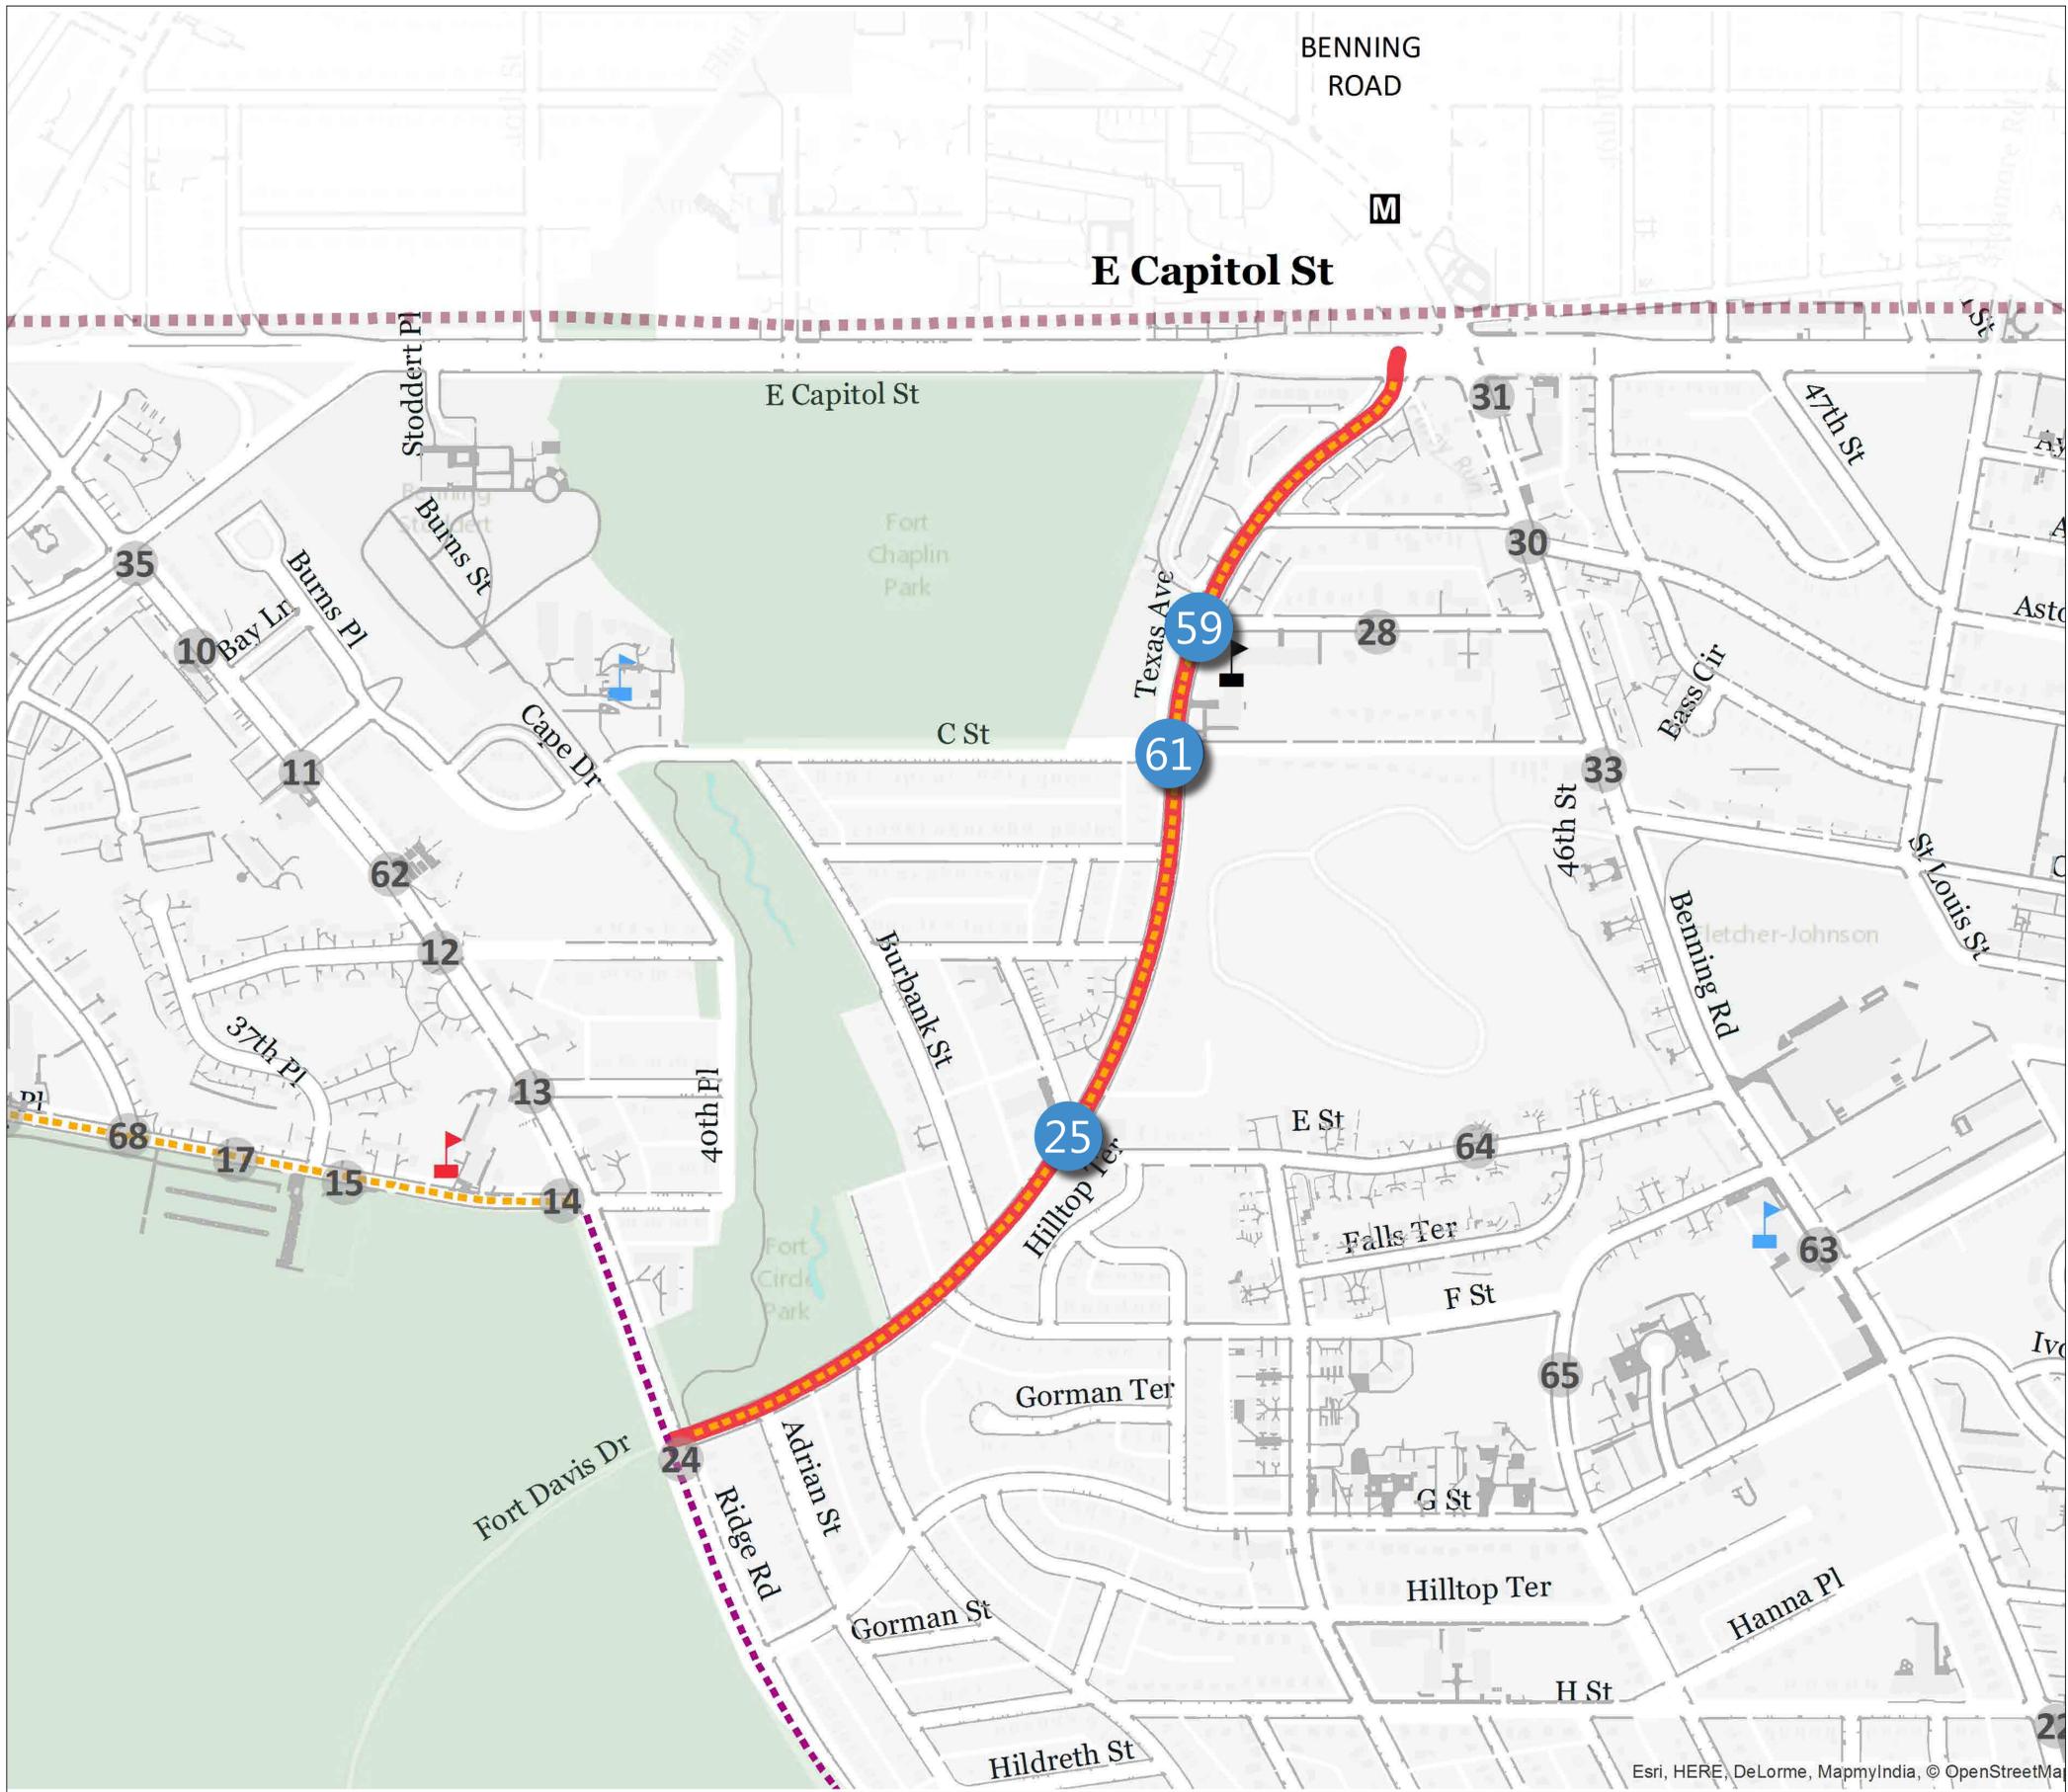
Texas Ave, E St, and Chaplin St SE intersect in the middle of the study area. This intersection is four-way stop-controlled, but E St and Chaplin St are significantly offset from each other and skewed. This geometry results in the stop bars on Texas Ave being close to 200 feet apart. There are three bus stops and multiple crosswalks within the intersection, and a large number of pedestrian crossings outside marked crosswalks, due to the placement of the stops and a convenience store which attracts a good deal of foot traffic.

The recommendation for this intersection is to replace the offset intersection with two distinct and separate intersections. The stop bar for southbound Texas Ave traffic will move to just north of E St. Chaplin will be re-aligned to be more perpendicular with Texas Ave, and Texas Ave will not be stop-controlled at Chaplin St. The bus stops will be moved into the space between Chaplin St and E St SE, closer to the existing crosswalks. The bus stop on E St SE will be improved, leveled, and connected to both the street and sidewalk. The realignment of Chaplin St provides an opportunity for green infrastructure and community congregating space, which may be advantageous given its location close to a church.

Some parking along Chaplin St will likely be impacted by the recommendations, but these losses may be offset by gains in available on-street parking on Texas Ave previously reserved for bus stops. There will be some right-of-way acquisition required from the property to the north of Chaplin St and Texas Ave.

Implementation Timeline	Long term 4-8 years
Estimated Project Cost	\$330,200
Right-of-Way Needed	Yes
Coordination Needs	Yes, WMATA, private landowners
Parking Impacts	Yes, but no net impact as parking eliminated on Chaplin will be added on Texas.
Green Infrastructure Project	Green plaza created, as well as proper stormwater collection
